EXTERIOR REHABILITATION PLAN FOR HISTORIC HOUSE  
34653 FREMONT BOULEVARD | FREMONT, CA

**SIEGEL & STRAIN** Architects

July 21, 2014

34653 Fremont Boulevard, Fremont, California

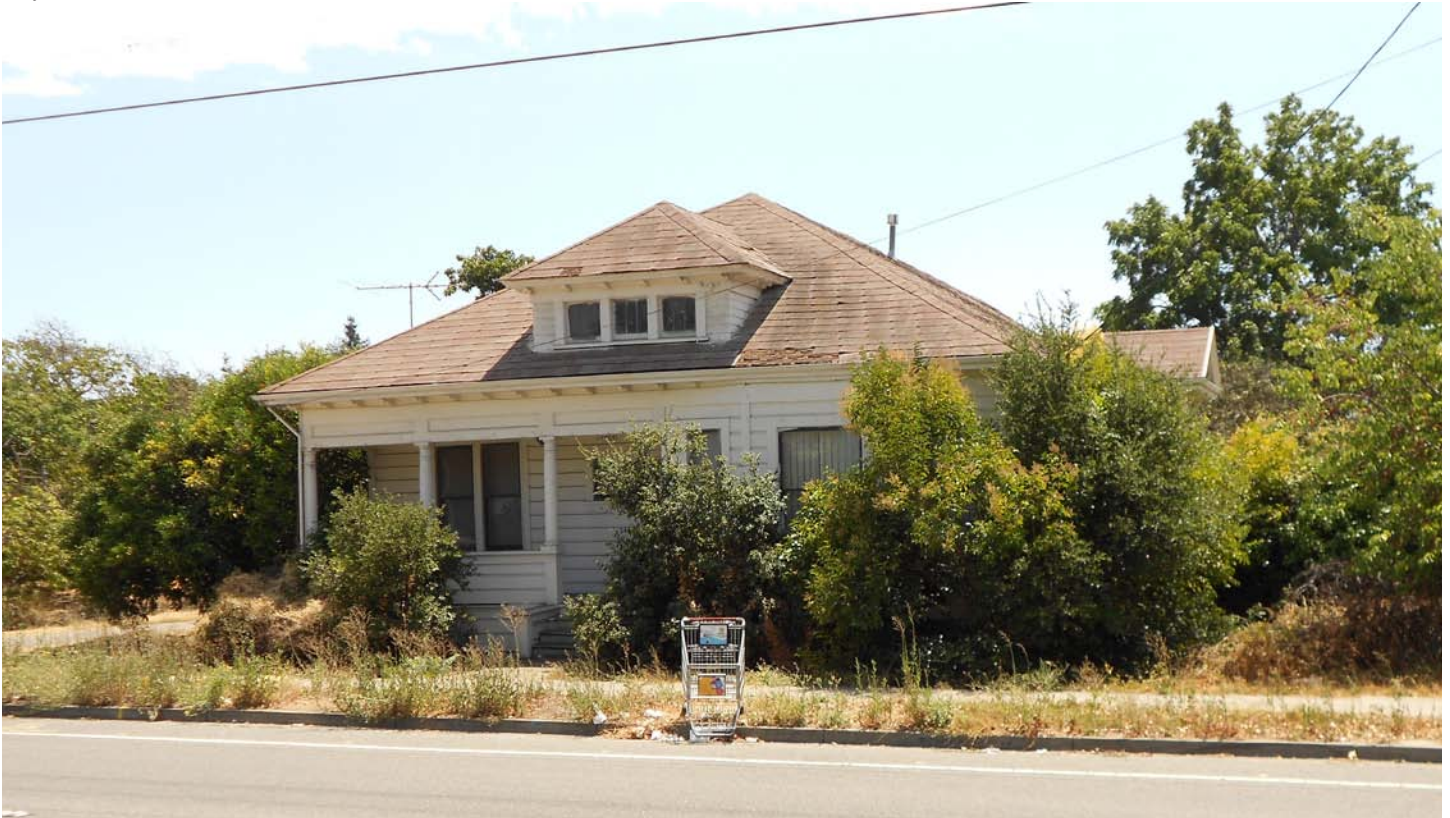
Figure 01: Front (north) elevation, looking south.

Figure 01: Front (north) elevation, looking south. (July, 2014) (S&S)

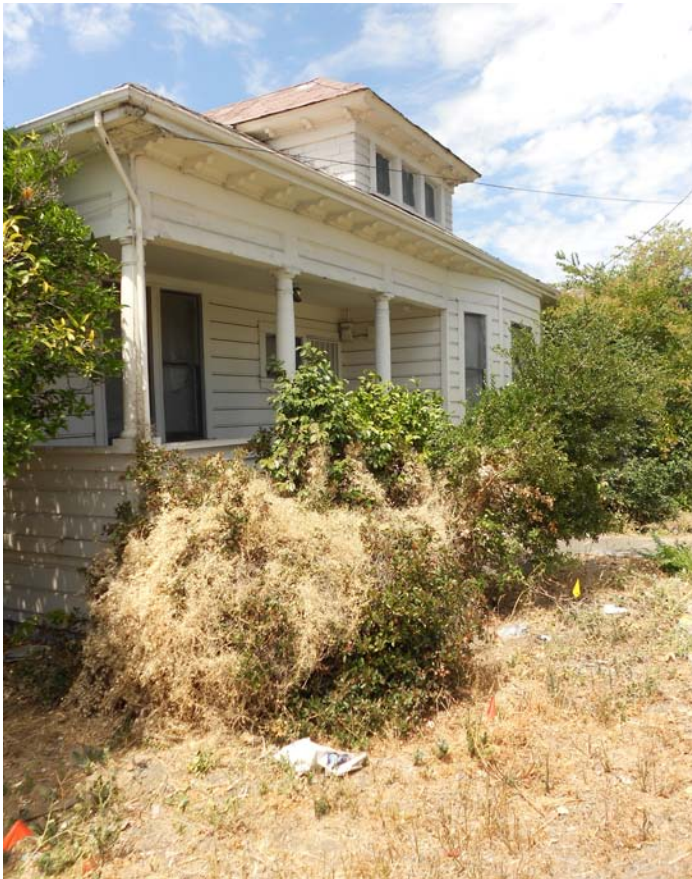
Figure 02: Front (north) elevation, looking west.

Figure 02: Front (north) elevation, looking west. (July, 2014) (S&S)

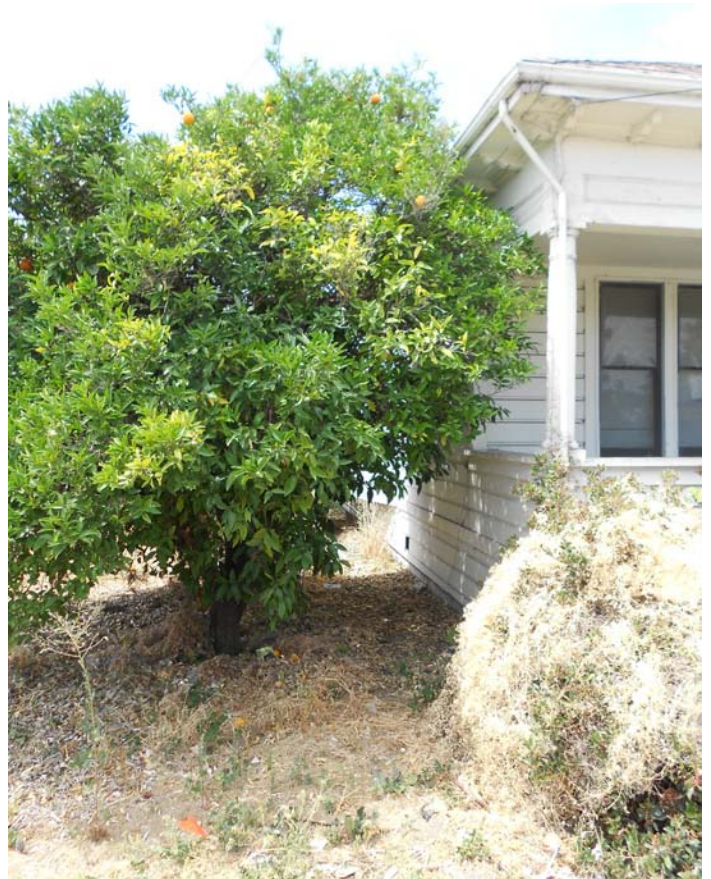
Figure 03: Northeast corner of house, looking south.

Figure 03: Northeast corner of house, looking south. (July, 2014) (S&S)

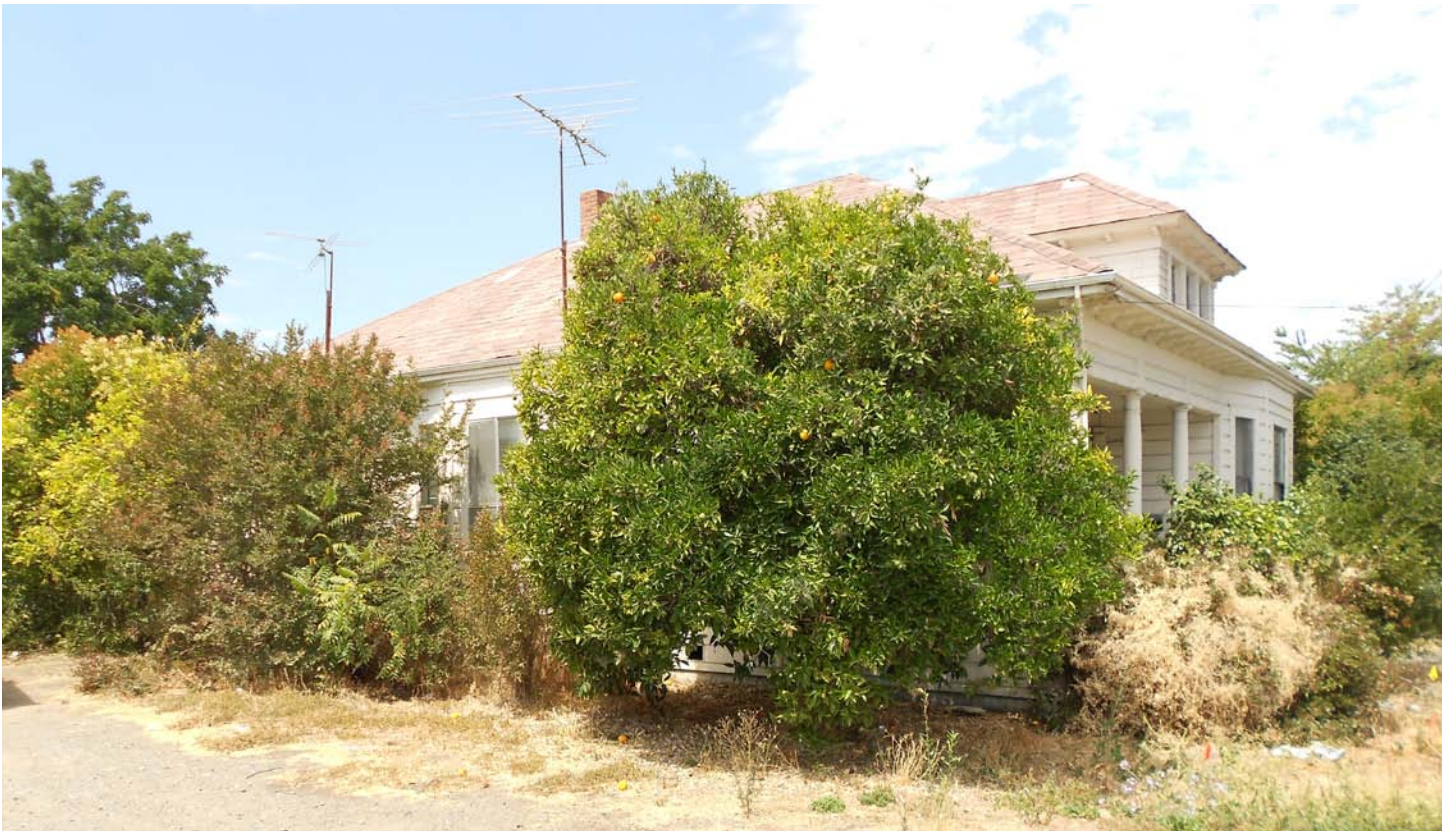
Figure 04: Looking west toward east (side) elevation (obscured by vegetation) and front (north) elevation at right.

*Figure 04: Looking west toward east (side) elevation (obscured by vegetation) and front (north) elevation at right. (July, 2014) (S&S)*

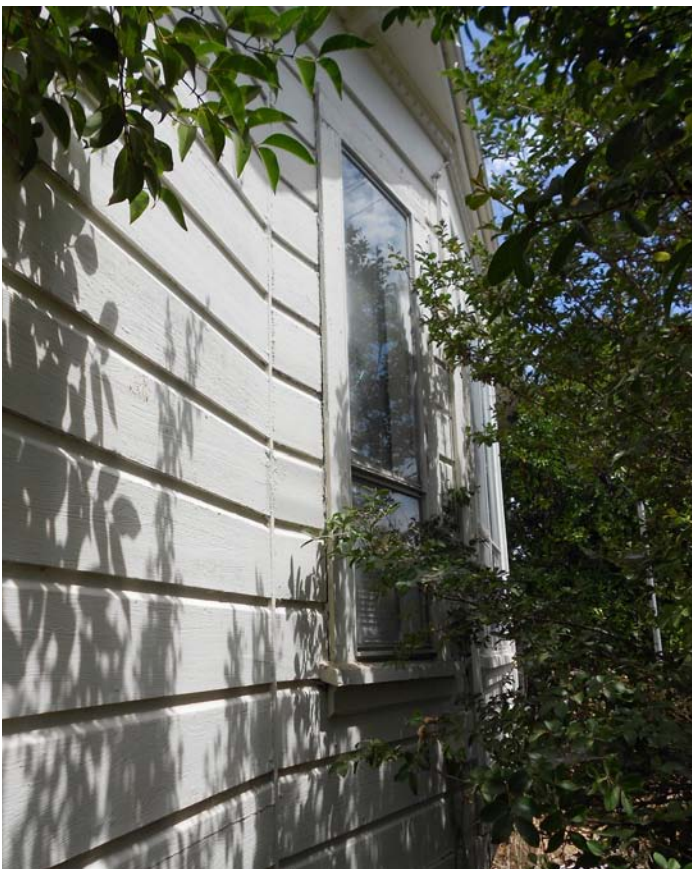
Figure 05: Detail of east elevation, looking north toward shallow bay window.

*Figure 05: Detail of east elevation, looking north toward shallow bay window. (July, 2014) (S&S)*

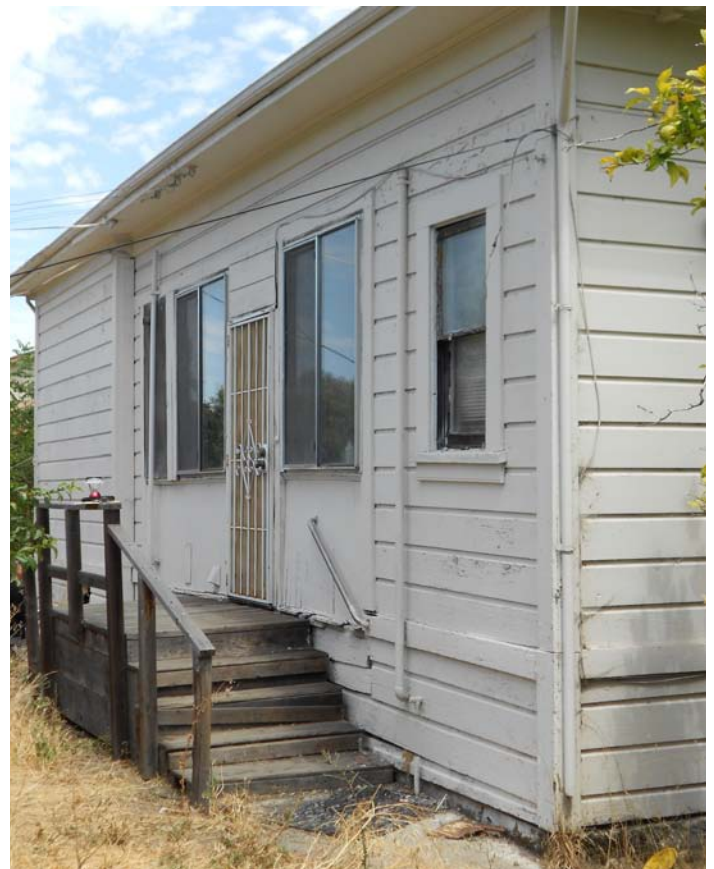
Figure 06: Southeast corner of house, looking northwest toward enclosed rear porch and added stair and landing.

*Figure 06: Southeast corner of house, looking northwest toward enclosed rear porch and added stair and landing. (July, 2014) (S&S)*

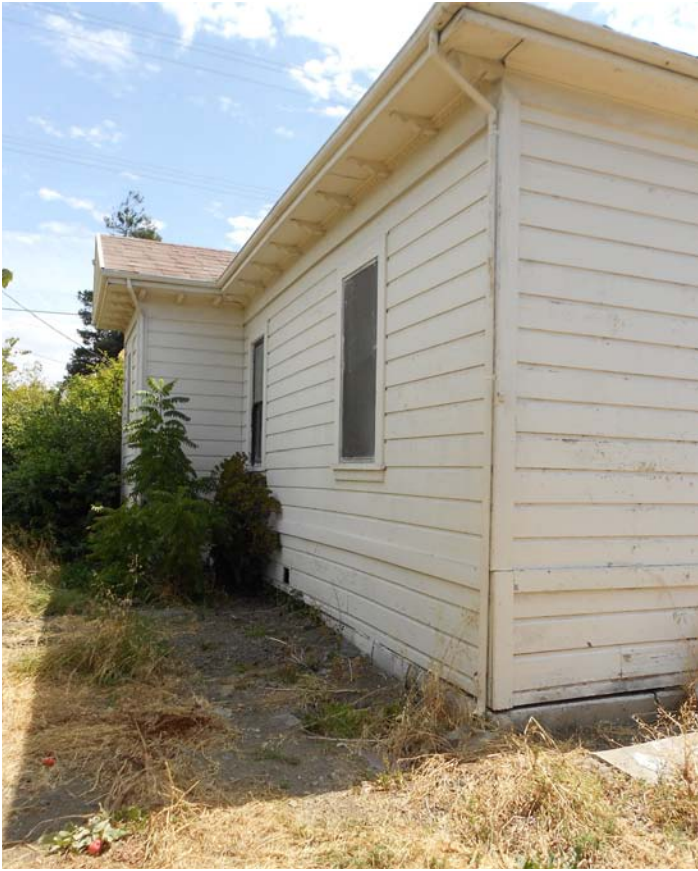
Figure 08: Southwest corner of house, looking north toward small projecting bath wing.

Figure 08: Southwest corner of house, looking north toward small projecting bath wing. (July, 2014) (S&S)

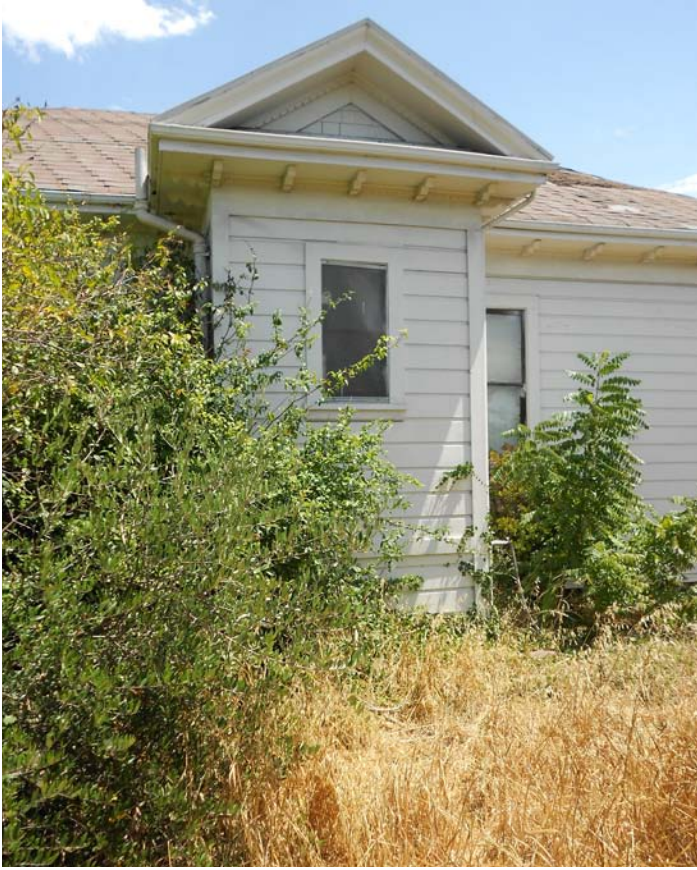
Figure 09: Detail of west elevation, looking east toward the small gable-roofed bath wing.

Figure 09: Detail of west elevation, looking east toward the small gable-roofed bath wing. (July, 2014) (S&S)

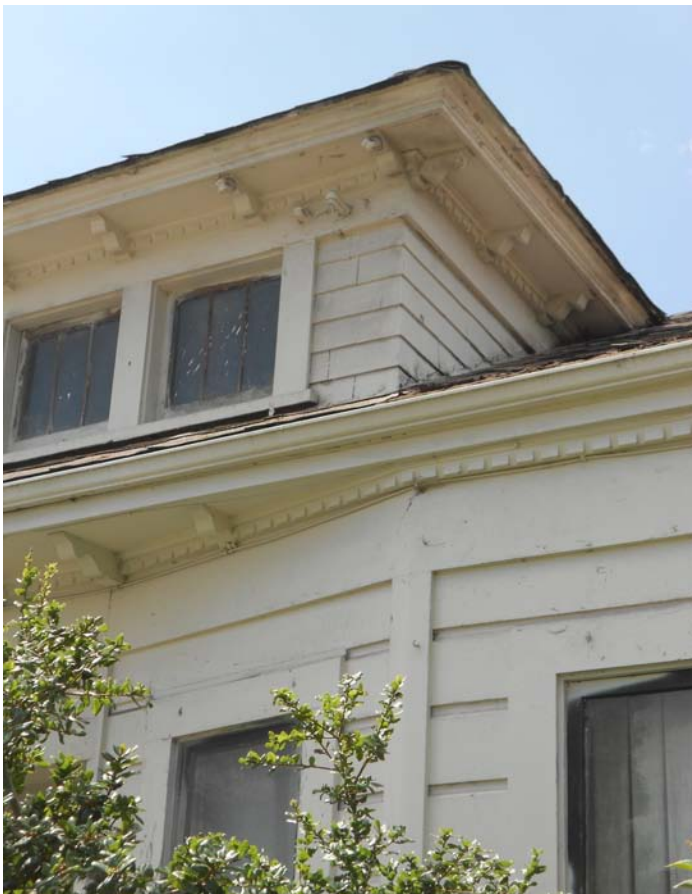
Figure 13: Detail of north elevation and dormer, showing elongated brackets and dentils below soffitted eaves. These ornamental features also occur at the side elevations, but not at the rear elevation.

Figure 13: Detail of north elevation and dormer, showing elongated brackets and dentils below soffited eaves. These ornamental features also occur at the side elevations, but not at the rear elevation. (July, 2014) (S&S)

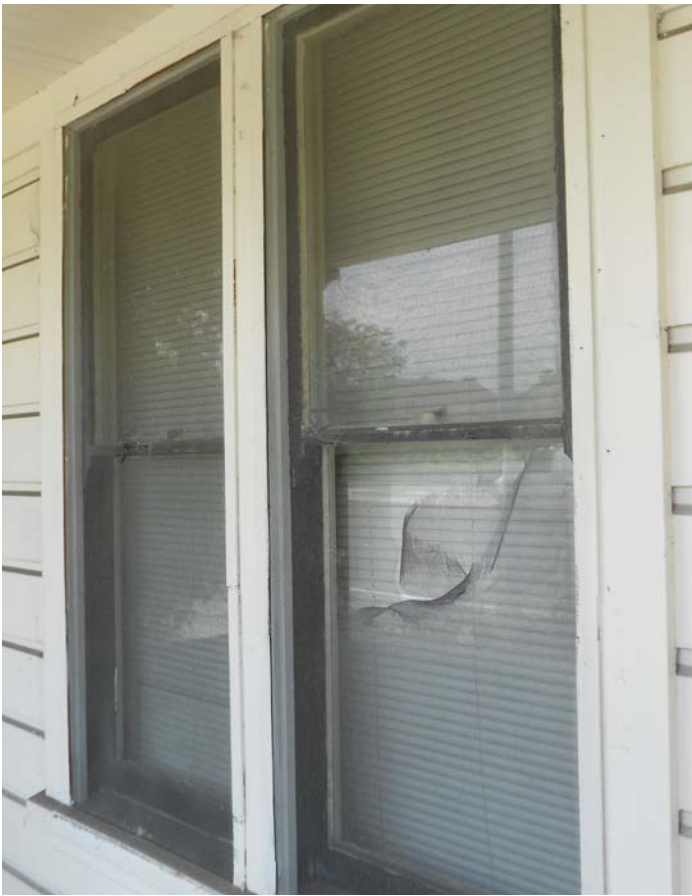
Figure 22: Original double hung wood sash windows at front porch are intact and in relatively good condition.

Figure 22: Original double hung wood sash windows at front porch are intact and in relatively good condition. (July, 2014) (S&S)

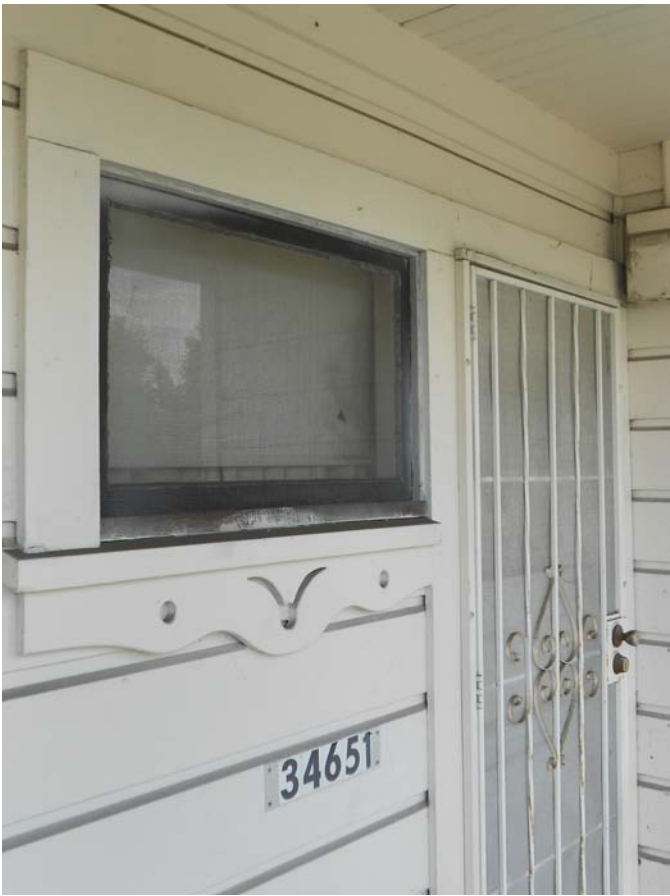
Figure 23: Original wood sash window with ornamental apron adjacent to front entry.

Figure 23: Original wood sash window with ornamental apron adjacent to front entry. (July, 2014) (S&S)

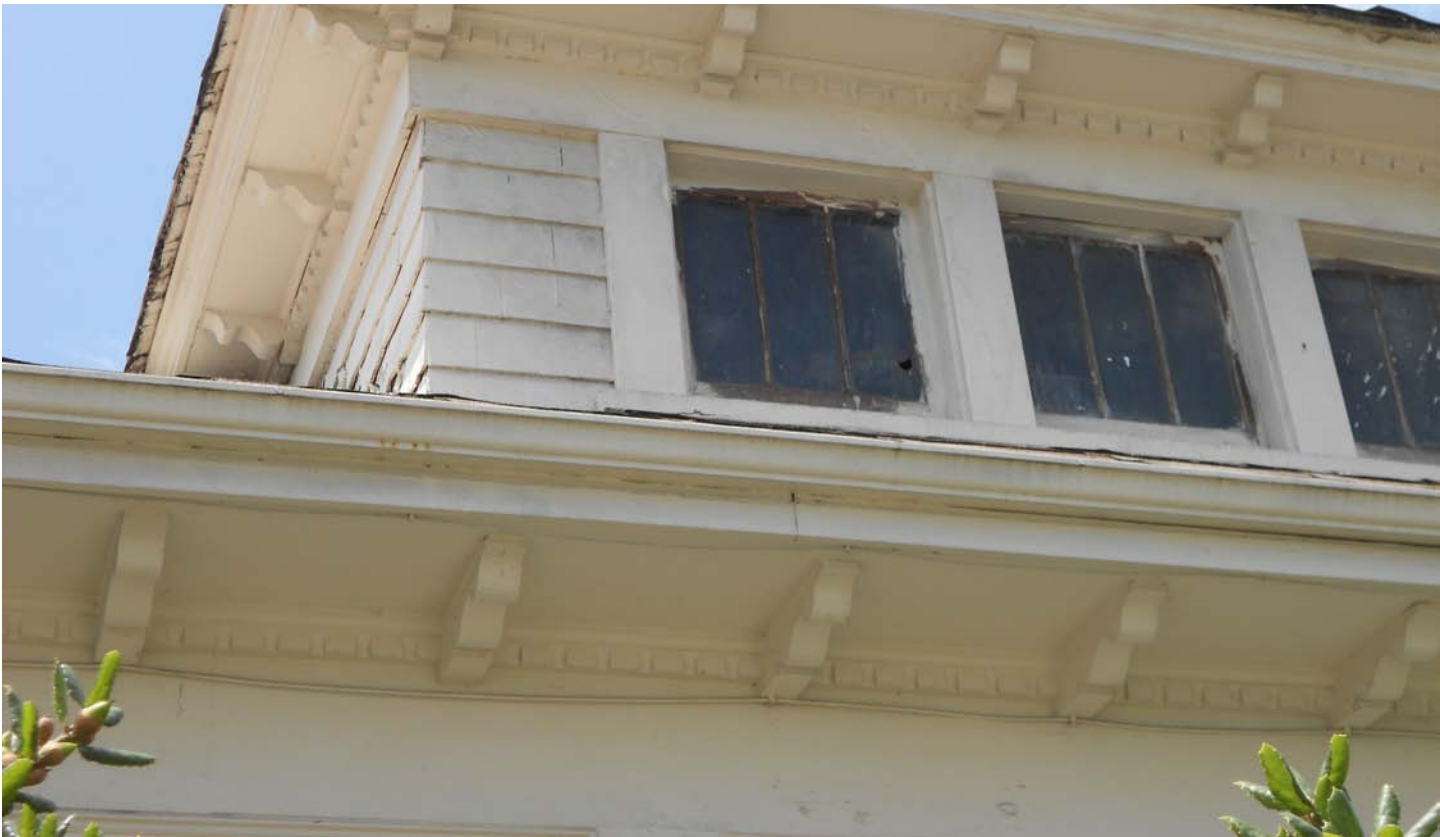
Figure 24: Detail of front elevation showing three-light wood sash windows at dormer.

Figure 24: Detail of front elevation showing three-light wood sash windows at dormer. (July, 2014) (S&S)

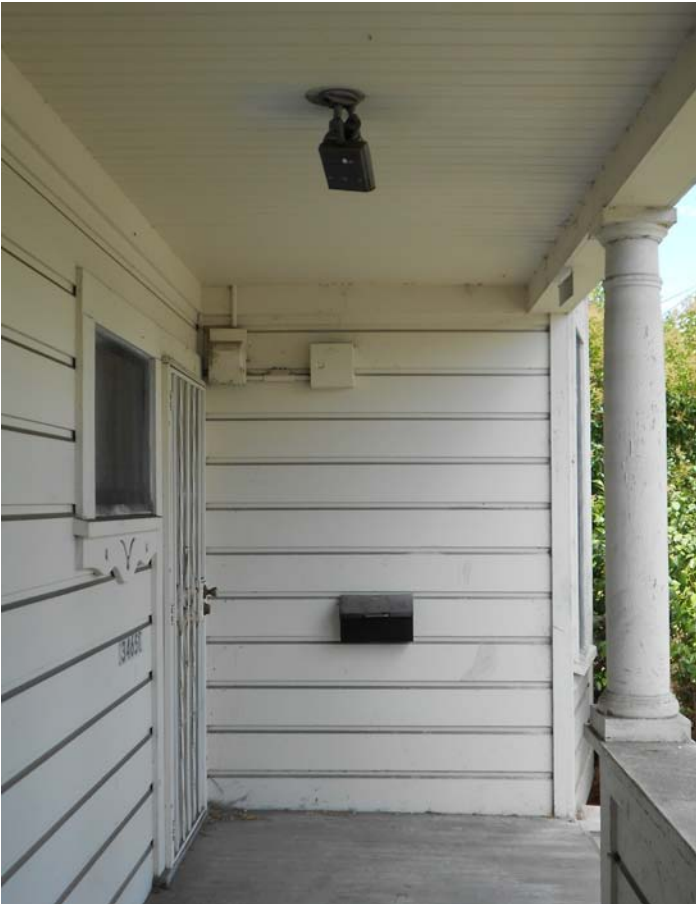
Figure 33: Front porch looking west.

Figure 33: Front porch looking west. (July, 2014) (S&S)

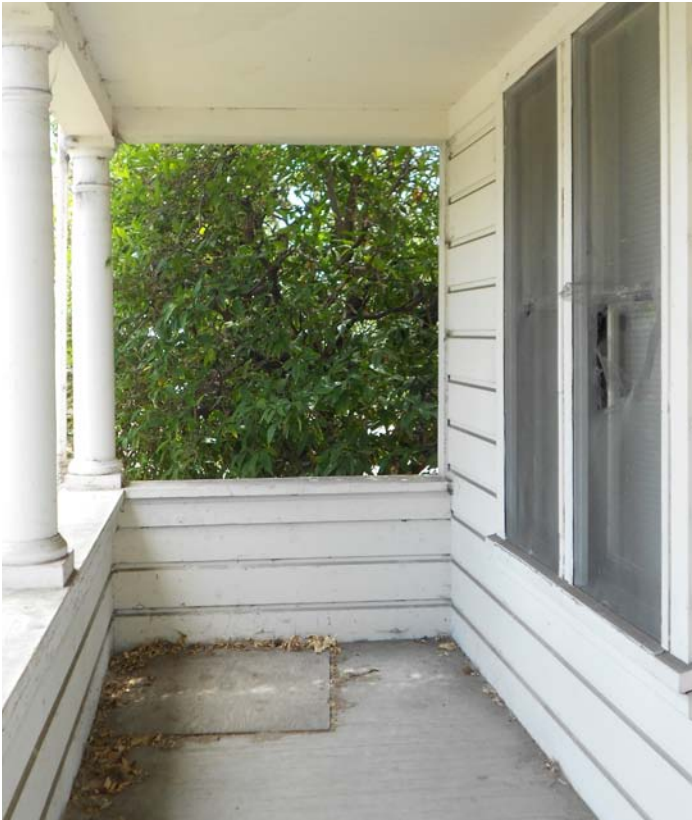
Figure 34: Front porch looking east.

Figure 34: Front porch looking east. (July, 2014) (S&S)

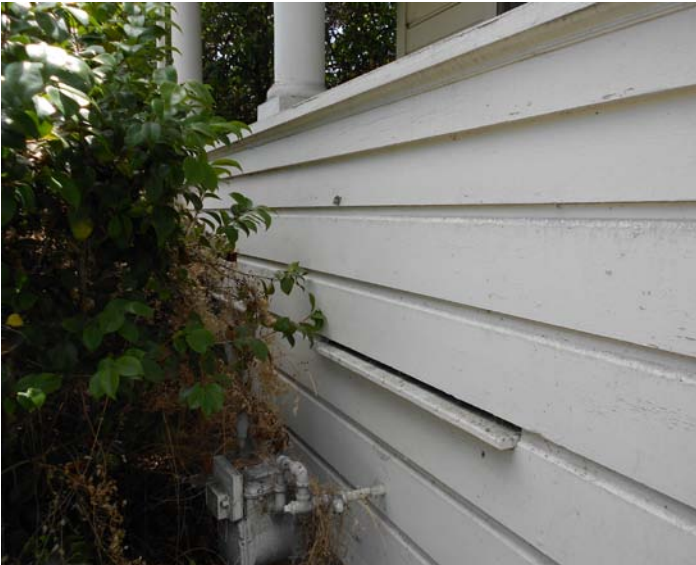
Figure 35: Narrow horizontal openings through the wood siding allows the sloping floor boards at the front porch to drain.

Figure 35: Narrow horizontal openings through the wood siding allows the sloping floor boards at the front porch to drain. (July, 2014) (S&S)

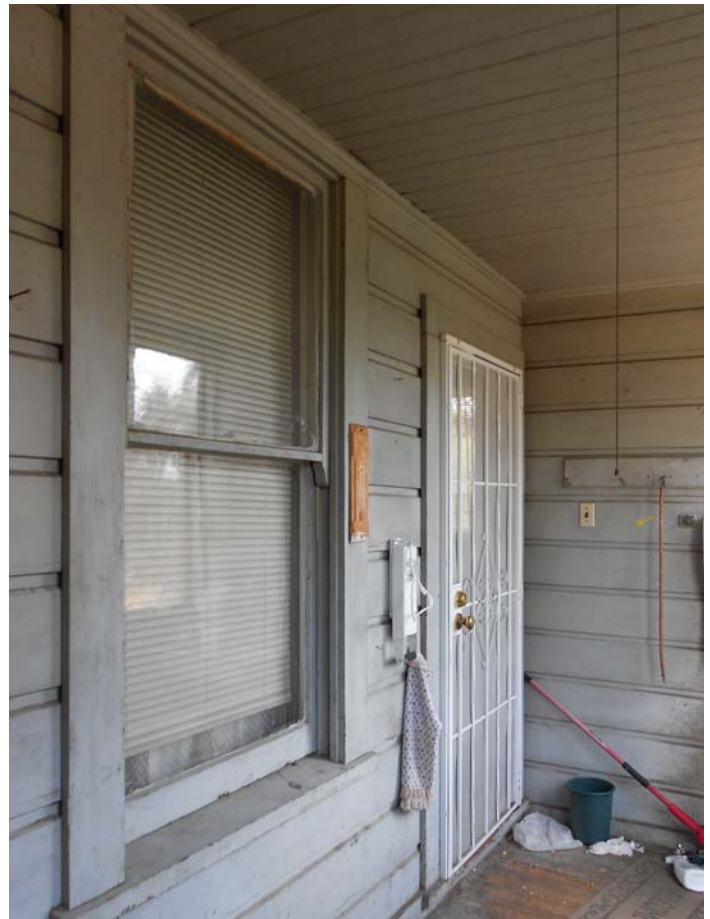
Figure 37: Enclosed rear porch looking northeast with original exterior siding, double-hung wood window and sloping wood floor still intact.

Figure 37: Enclosed rear porch looking northeast with original exterior siding, double-hung wood window and sloping wood floor still intact. (July, 2014) (S&S)

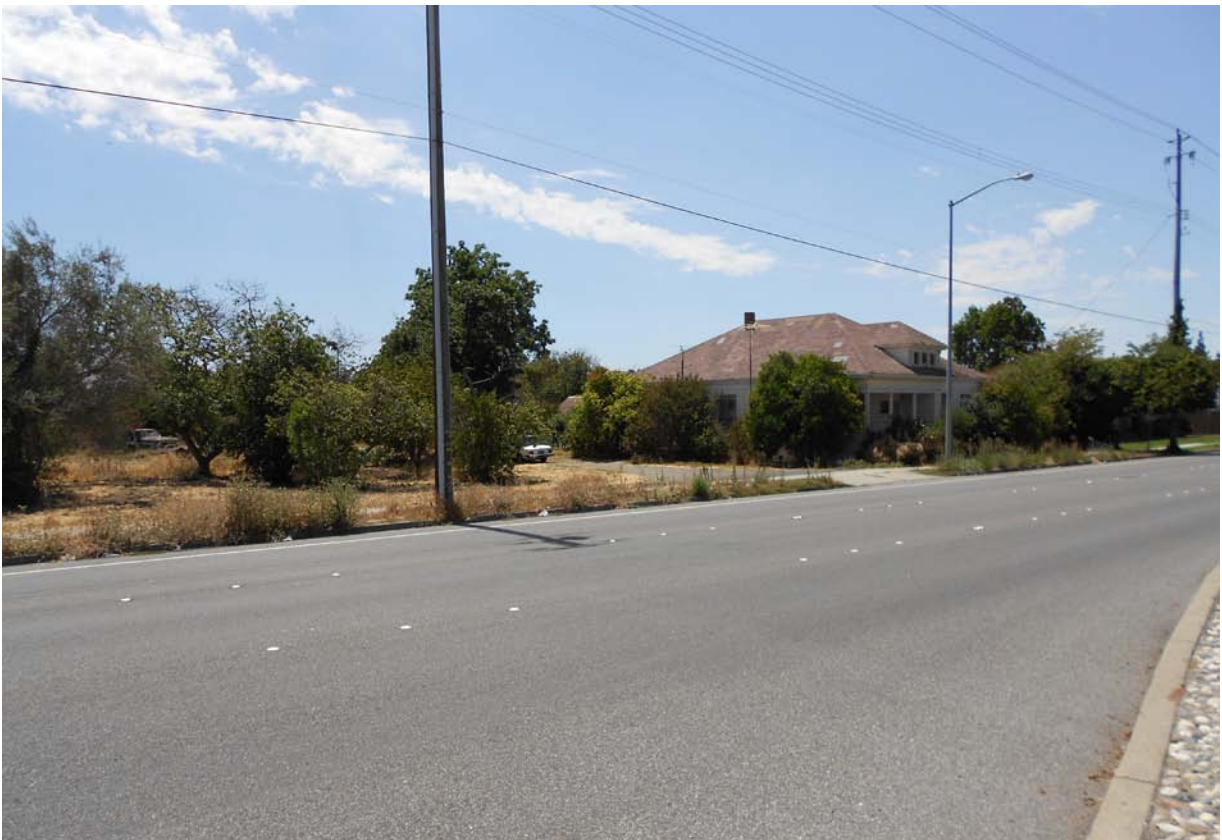
Figure 44: House viewed from Fremont Boulevard, looking southwest. New development, sited east and south of the house, should allow an unobstructed view of the house from Fremont Boulevard.

*Figure 44: House viewed from Fremont Boulevard, looking southwest. New development, sited east and south of the house, should allow an unobstructed view of the house from Fremont Boulevard. (July, 2014) (S&S)*

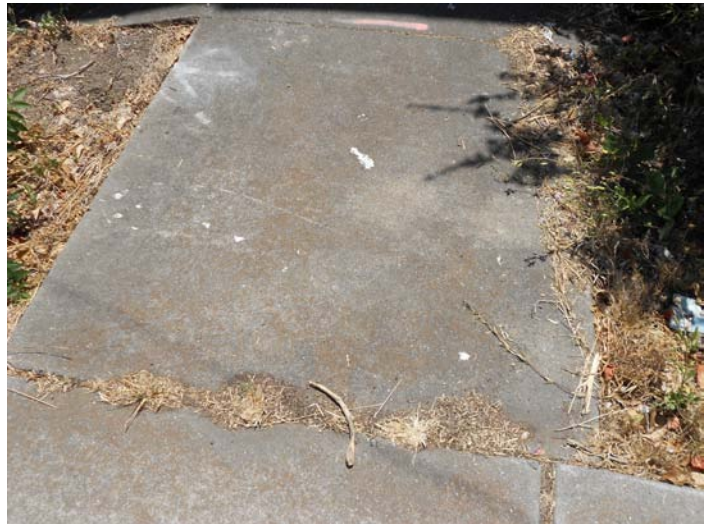
Figure 48: A concrete path leads from the public sidewalk to the front porch and encircled the house. Portions remain and should be protected.

Figure 48: A concrete path leads from the public sidewalk to the front porch and encircled the house. Portions remain and should be protected. (July, 2014) (S&S)
